INSTALLATION RESTORATION PROGRAM PHASE I: RECORDS SEARCH ELLSWORTH AFB SOUTH DAKOTA

United States Air Force
STRATEGIC AIR COMMAND
Deputy Chief of Staff
Engineering and Services
Offutt AFB, Nebraska 68113

September 1985

ENGINEERING-SCIENCE 57 Executive Park South, Suite 590 Atlanta, Georgia 30329

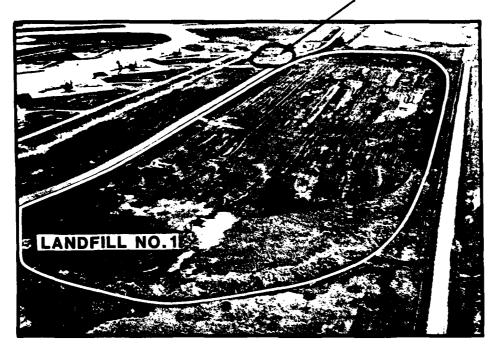
Landfill No. 1 (in foreground)
Landfill No. 6 (in background)

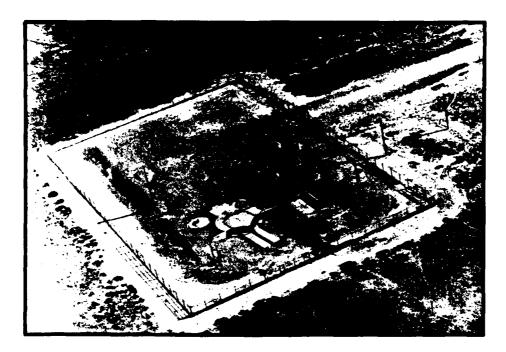
Launch Facility - Typical (Spill Site Nos. 2,5 and 6)
